Foundation Problems and Solutions at the Bridge River, Powerhouse No. 1

H. Taylor
B. C. Hydro

A. P. Joseph
B. C. Hydro

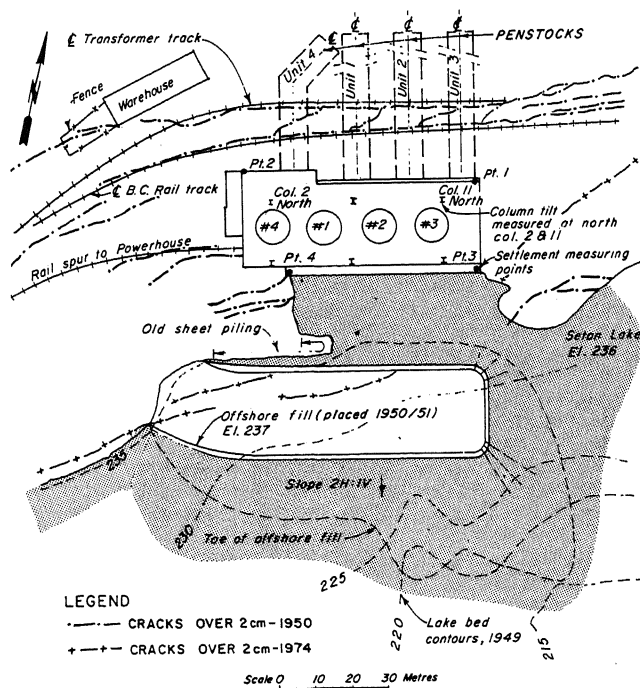
Fig. 5. Ground Cracking in 1950 and 1974 and Instrumentation - 1951

- I. Extensive cracking occurred behind and beyond the powerhouse.
- II. The concrete penstock tunnels under the road and railway, through which the penstocks pass into the powerhouse developed cracks up to 6 mm wide. This indicated that the powerhouse had shifted towards the lake.
- III. A small penstock to the Old Powerhouse had lengthened 2 mm at an expansion joint.
- IV. The 100 mm water main from the temporary plant to the townsite fractured.
- V. The B.C. rail track, about 250 m east of Powerhouse No. 1 had settled up to 200 mm and moved out of alignment.

These events caused considerable concern about the security of the powerhouse. Dr. V. Dolmage (B.C. geologist) was consulted and he advised the B.C. Electric Company to seek the assistance of Dr. Terzaghi on this serious matter. A detailed survey of the ground cracks revealed that they ranged from 0.3 to 7.6 mm wide in an arc around the powerhouse and ran several hundred metres along the railway tracks as shown on Fig. 5.

During the initial assessment of the ground movements it was believed that lowering of the lake level was the cause. However Dr. Dolmage was of the opinion that water under pressure from the tunnels could be causing high uplift under the powerhouse. Dr. Dolmage also indicated that surface flows could be feeding the aquifer high up the hillside. He therefore recommended that surface water be diverted directly to the lake.

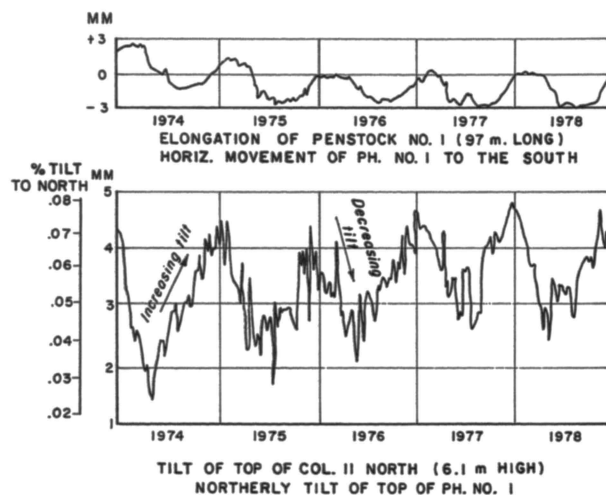
Fig. 9. Typical Instrumentation Results (1974 to 1978)

Instrumentation devices were installed which have alarms that would be activated if extensive downhill movement or tilt of the powerhouse was to occur. The penstock elongation indicates southerly (horizontal) movement of the powerhouse towards the lake and column tilt indicates tilt of the top of the powerhouse to the north, typical data from these devices are shown on Fig. 9.

The penstock elongation measurements indicated a cyclical trend of the powerhouse moving southerly in the winter and spring and northerly in the summer and fall. There has been no long term trend of southerly (horizontal) movement of the powerhouse towards the lake but only seasonal fluctuation.

Similarly the powerhouse tilts to the north on a seasonal basis only and shows no long term trend of increasing tilt.

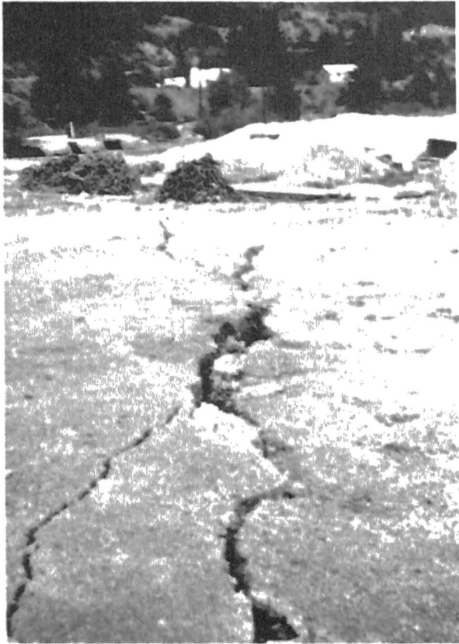
Fig. 10. Cracking in Offshore Fill, April 1974

In April 1974 ground cracking up to 100 mm wide occurred across the offshore fill in front of the powerhouse and along part of the railway embankment to the east of the powerhouse, as shown on Figs. 5 and 10.

Dr. Hardy saw no evidence of significant subsidence of soil on the lake side of the crack nor of significant lateral displacement and concluded that the cracks were due to lifting of the fill by the artesian pressures. The occurrence of these cracks did not represent a general deterioration of the subsoil stability conditions beneath the powerhouse. They were described as a re-appearance of the same type of cracks that were observed in 1950 and 1951.

In early 1974, uplift pressure under the offshore fill is assumed to have caused further cracking. For some time there was no evidence of differential settlement on one side of the crack with respect to the other side. However slumping on the lake side of the offshore fill was observed a week or two after the initial cracks appeared.

Dr. Hardy recommended that a drilling program be undertaken to see if a pervious sandy-gravel zone could be located where a bleeder well system could be established.

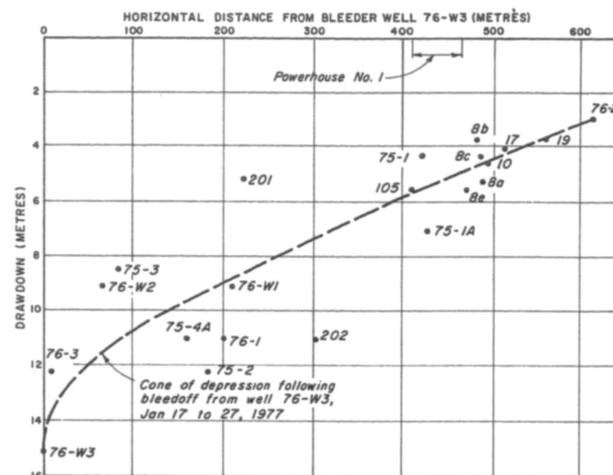
Fig. 14. Artesian Pressure Drawdown due to Opening Bleeder Well, January 1977

From January 14 to 24, 1977, Bleeder Well 76-W3 was opened and readings were taken of the piezometric levels in the piezometers around the Powerhouse No. 1. The results, shown on Fig. 14, are plotted as a cone of depression from Bleeder Well 76-W3. With a 15 m reduction in pressure head at the bleeder well, a drawdown of about 5 m was observed at Powerhouse No. 1, approximately 425 m from the bleeder well.

Further tests carried out in April 1978 confirmed that a single bleeder well alone would be capable of halting rapidly rising artesian pressures at Powerhouse No. 1. The criteria for operating the bleeder wells was prepared for the Operating Staff to follow in their long term protection of the powerhouse.

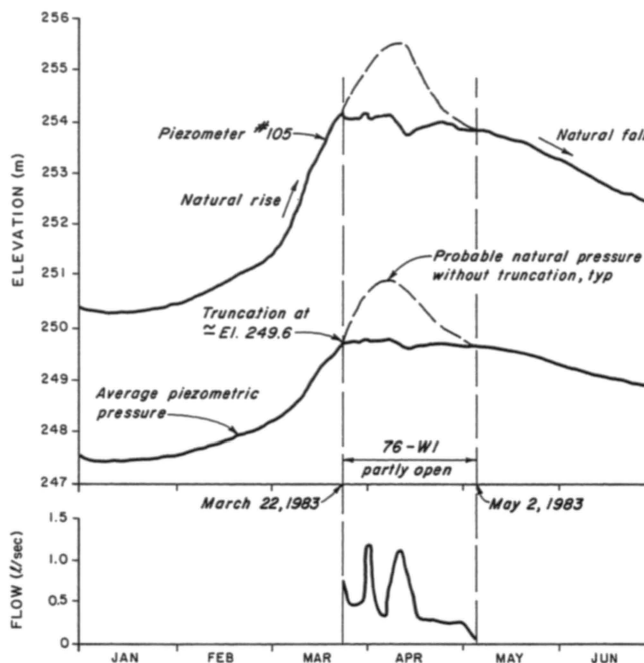
Fig. 15. Bleeder Well Test Results, 1983

This was successfully accomplished, as indicated by the results on Fig. 15, and the average artesian pressure was held at El. 249.6, with only minor variation, for a period of 6 weeks. Bleeder well 76-W1 was closed when the natural decline in artesian pressure went below El. 249.6.
